Manhole Inspection Summary

Manhole # S39C__012MH

Insp Date: **11/6/08 11:27 AM**

Location Address: **1009 new hope circle**

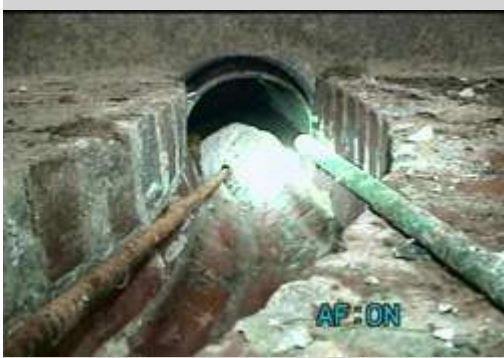
Misc

channel debris

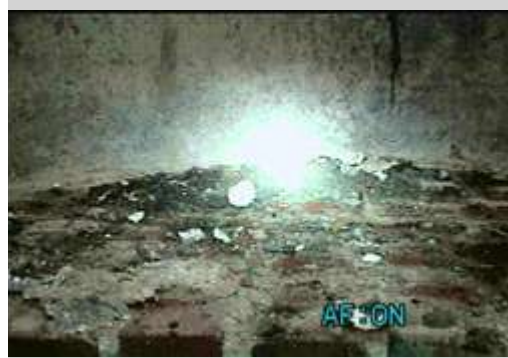
misc

bench debris

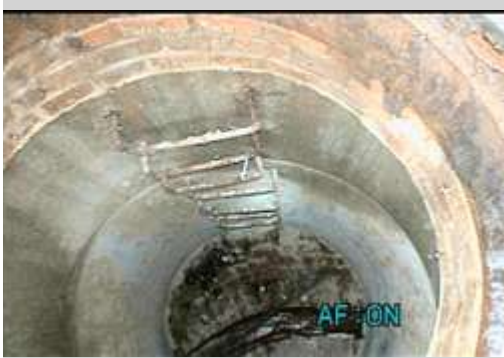
Defect 1

Steps Count: **8** Missing: **0** ☒ **Corroded**

corr steps

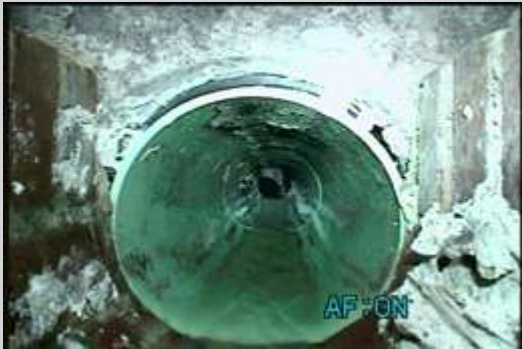
12 O'Clock Outflow

8 in. Circular Gravity Sewer
Pipe Out @ 12 O'Clock

Infiltration: **None** Pipe Seal Cond: **Unknown**

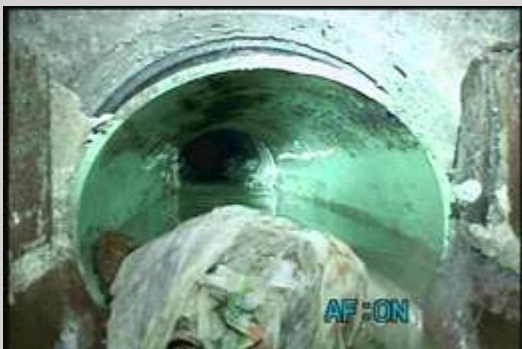
5 O'Clock Inflow

8 in. Circular Gravity Sewer
Pipe In @ 5 O'Clock

Infiltration: **None** Pipe Seal Cond: **Unknown**
